## Eagle Lake

Survey Date: July 10, 2018

# Eagle Lake Aquatic Plant Survey 2018

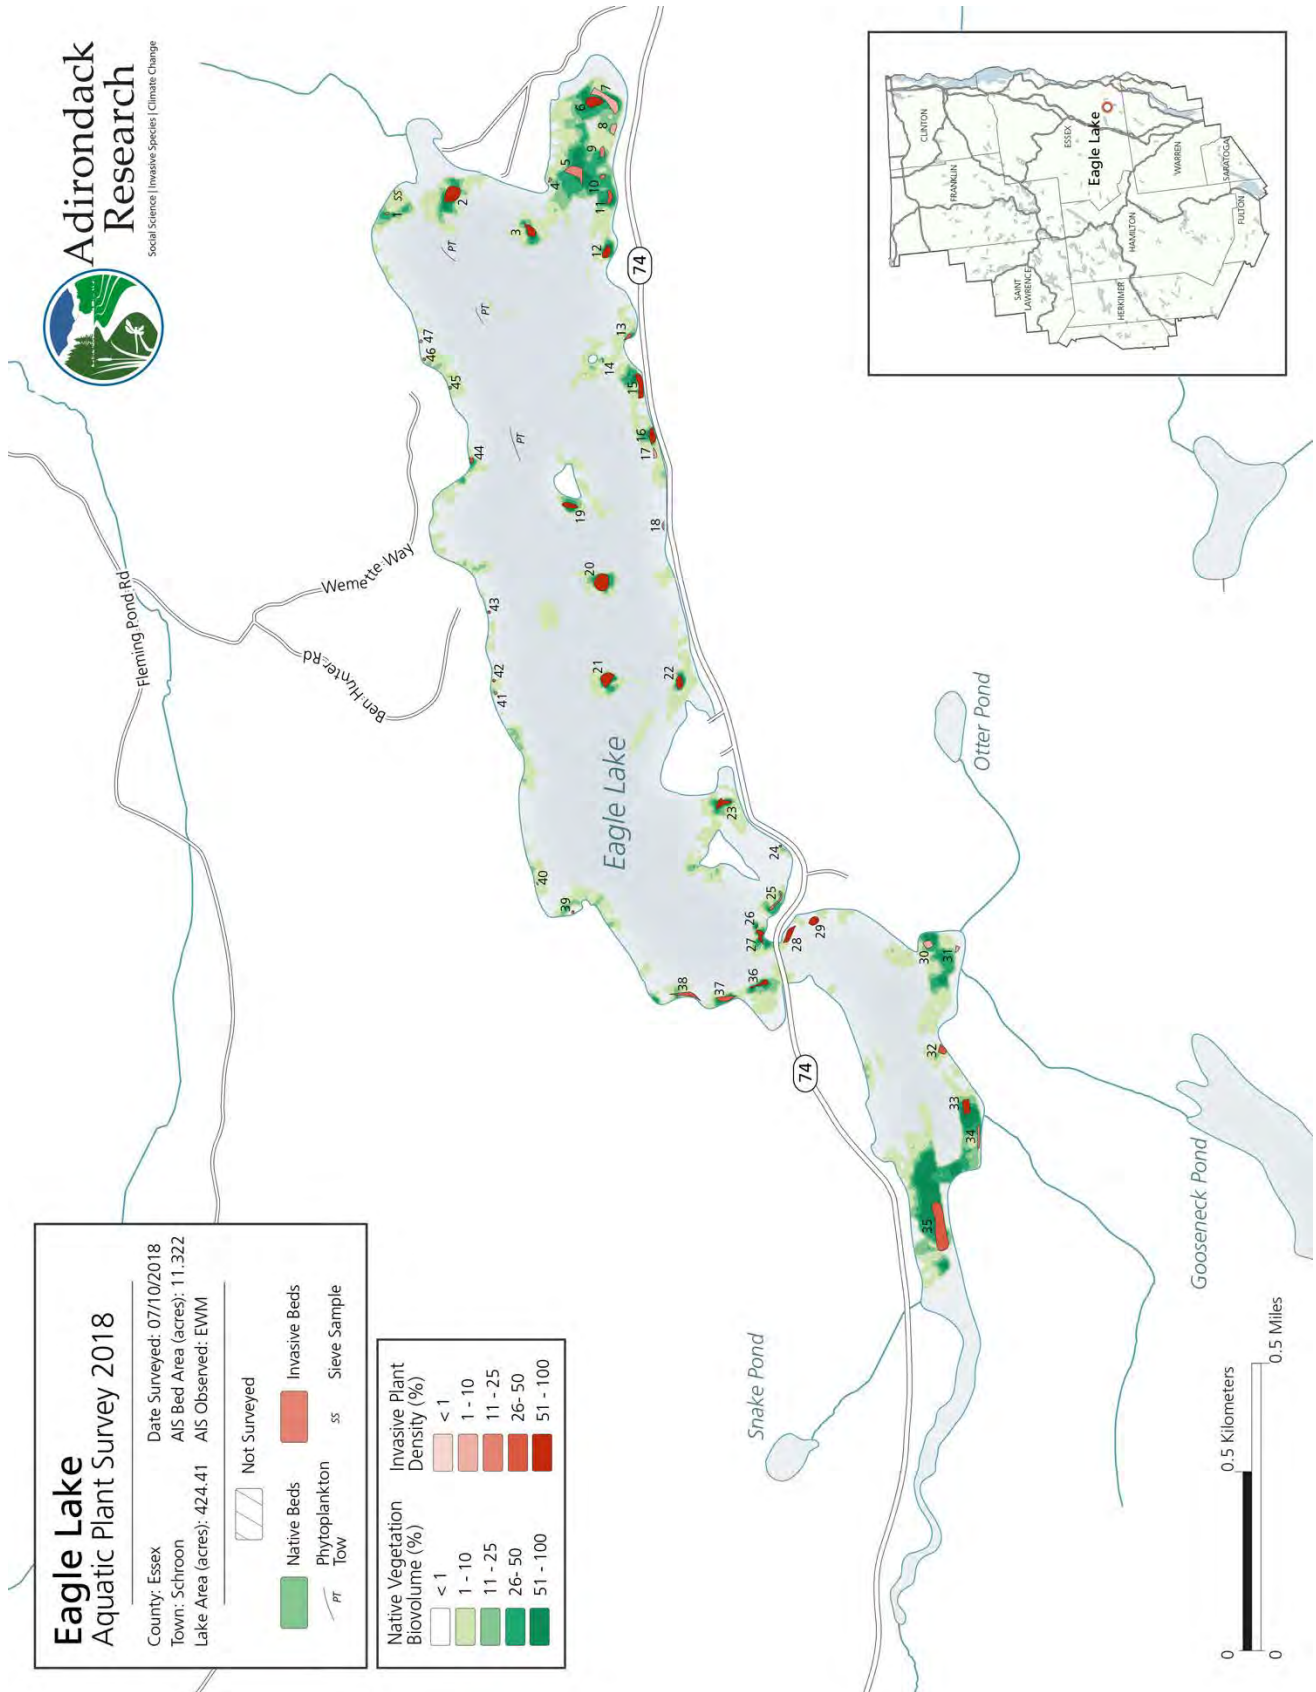
A total of 30 invasive *Myriophyllum spicatum* (Eurasian watermilfoil) plant beds were mapped. *Myriophyllum spicatum* was first discovered on Eagle Lake in the 1970's. In the past, the Eagle Lake Property Owners, Inc. has managed the milfoil, which forms several dense mono-cultures around the perimeter of the lake and at atolls away from shore. *Potamogeton crispus* (curly-leaf pondweed) is another known invasive species in Eagle Lake, though none was detected during this survey. *Potamogeton crispus* has a unique biology that may factor into detection. It is usually one of the first plants to emerge each spring, and by mid-June or July the plants typically have died off for the season.

County: Essex Date Surveyed: 07/10/2018  
 Town: Schroon AIS Bed Area (acres): 11.322  
 Lake Area (acres): 424.41 AIS Observed: EWM
