## Fulton Chain Lakes, Fifth Lake

**Survey Date:** June 24, 2019

### Fulton Chain - Fifth Lake Aquatic Plant Survey 2019

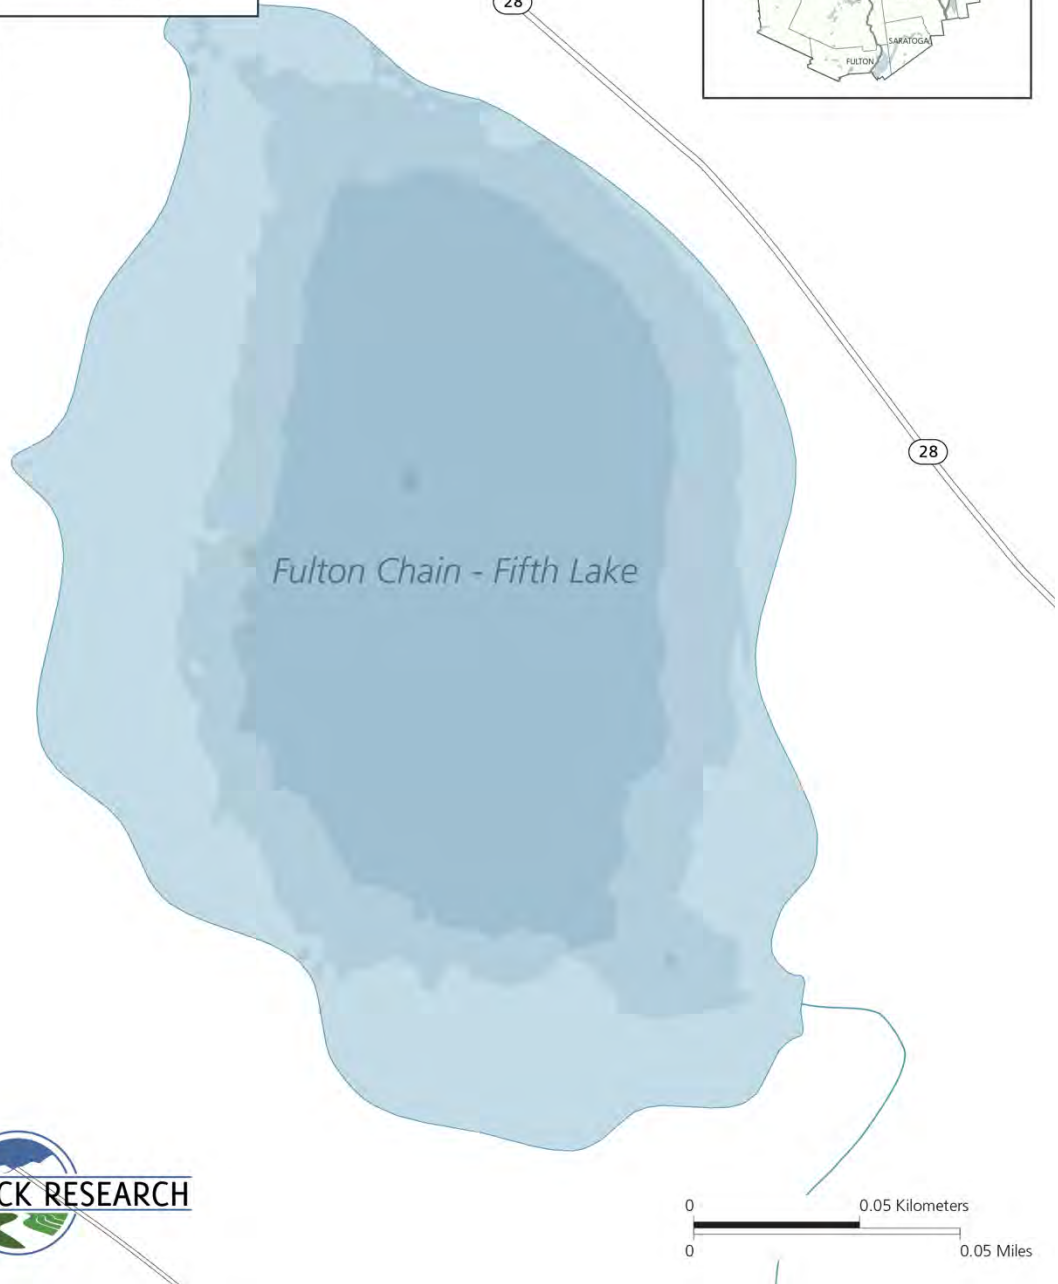
### Fulton Chain - Fifth Lake Aquatic Plant Survey 2019

County: Hamilton      Date Surveyed: 06/24/2019  
 Town: Inlet            AIS Bed Area (acres): 6.41  
 Lake Area (acres): 13.78      AIS Observed: VLM & EWM

#### Bathymetry (ft)
