Lake Narrative

Hadlock Pond

Survey Date: August 1 & 6, 2018

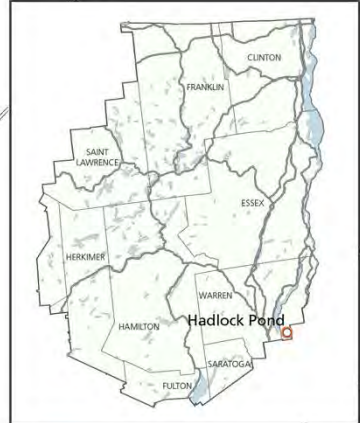
Hadlock Pond
Bathymetry Survey 2018

County: Washington Date Surveyed: 08/06/2018
 Town: Fort Ann AIS Bed Area (acres): 10.226
 Lake Area (acres): 194.18 AIS Observed: EWM
