Moody Pond

Survey Date: August 21, 2019

Lake Description

Aquatic Invasive Plant Presence

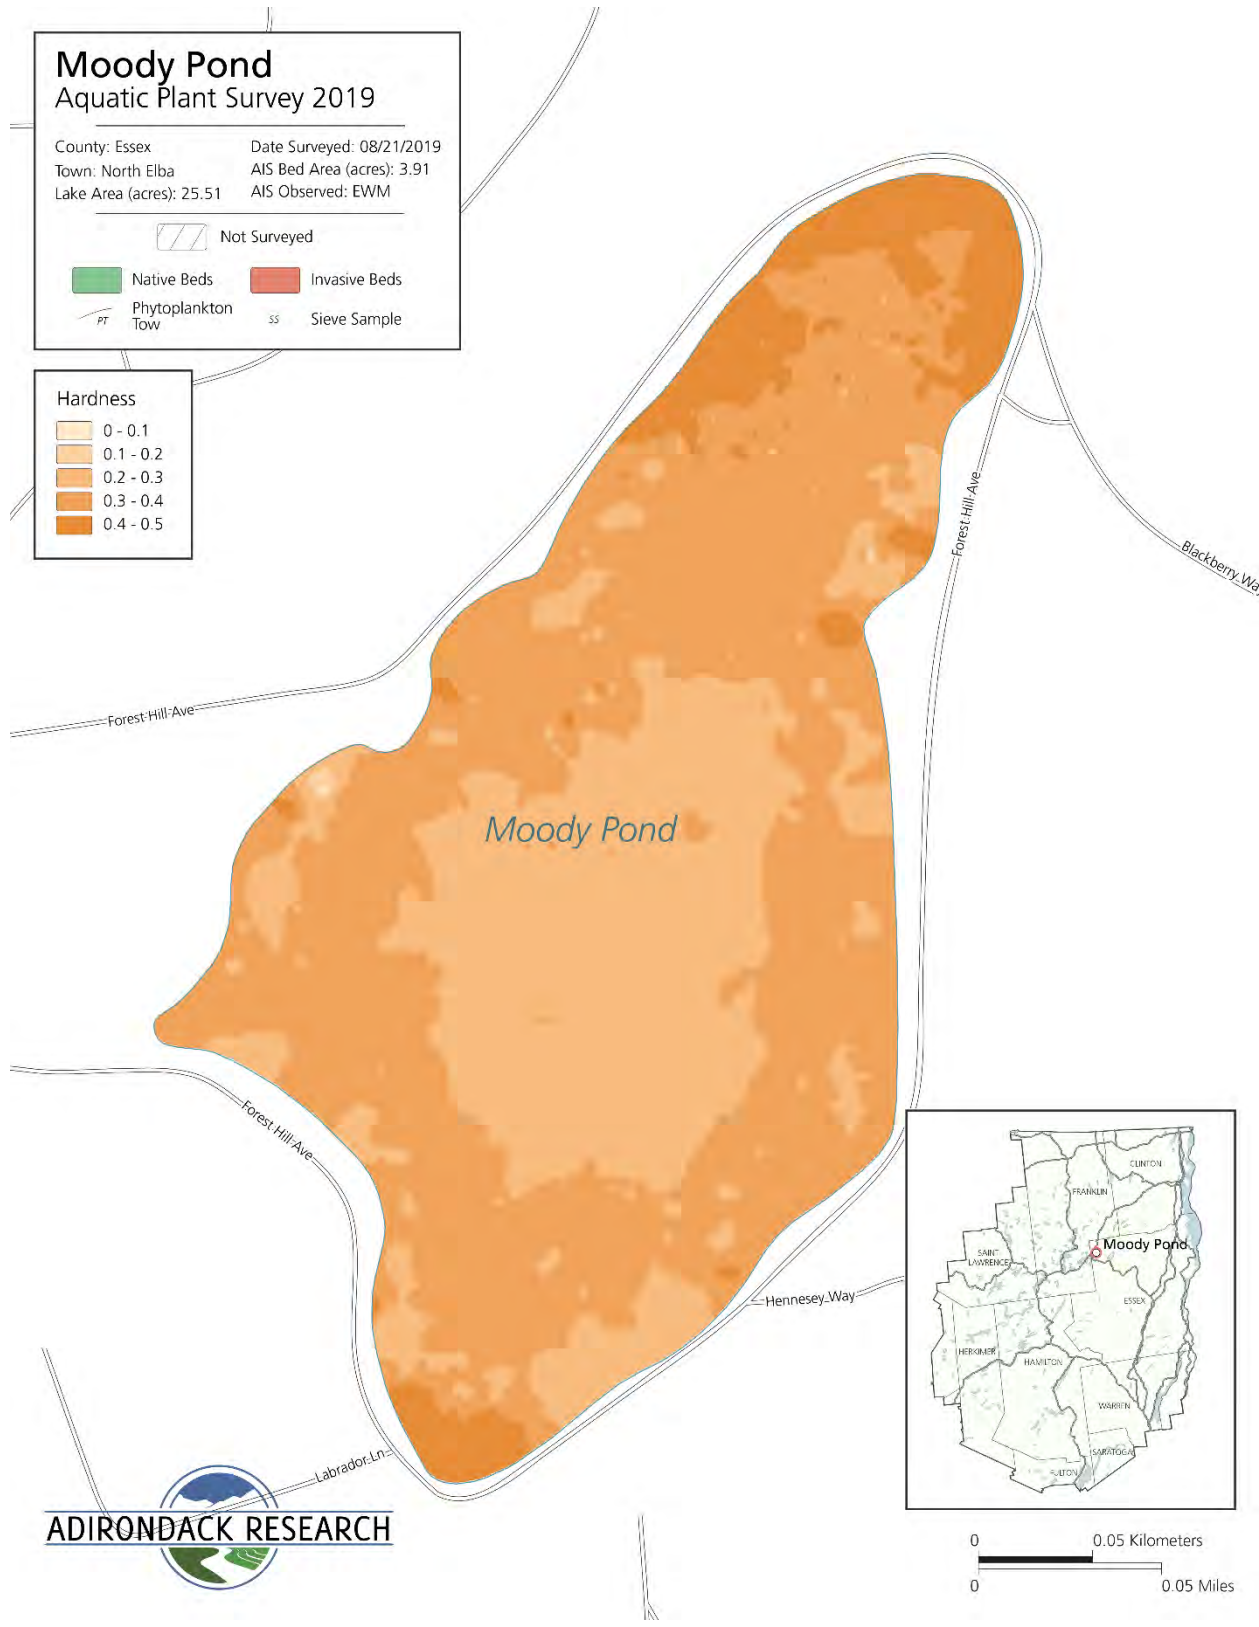
Invasive Species Percent Cover (See map on adjacent page)

Myriophyllum spicatum (Eurasian watermilfoil) was first detected in Moody Pond in 2018. A total of 11 plant beds were mapped.

Eurasian Watermilfoil				Eurasian Watermilfoil			
Bed	Size (Ac.)	Size (Sq. Ft.)	% Cover	Bed	Size (Ac.)	Size (Sq. Ft.)	% Cover
1	.01	561.55	1-10	9	.03	1168.21	51-100
2	.05	2387.88	11-25	10	.63	27393.70	11-25
3	.02	799.46	1-10	11	.0005	20.35	51-10
4	.06	2756.79	11-25				
5	.34	14955.80	1-10				
6	.06	2470.38	11-25				
7	.05	2175.78	26-50				
8	2.64	115046.00	51-100				
				Asian Clam		Spiny Waterflea	
				Present (Y/N)		Present (Y/N)	
				No		No
