Simon Pond

Survey Date: August 22 and 26, 2019

Lake Description

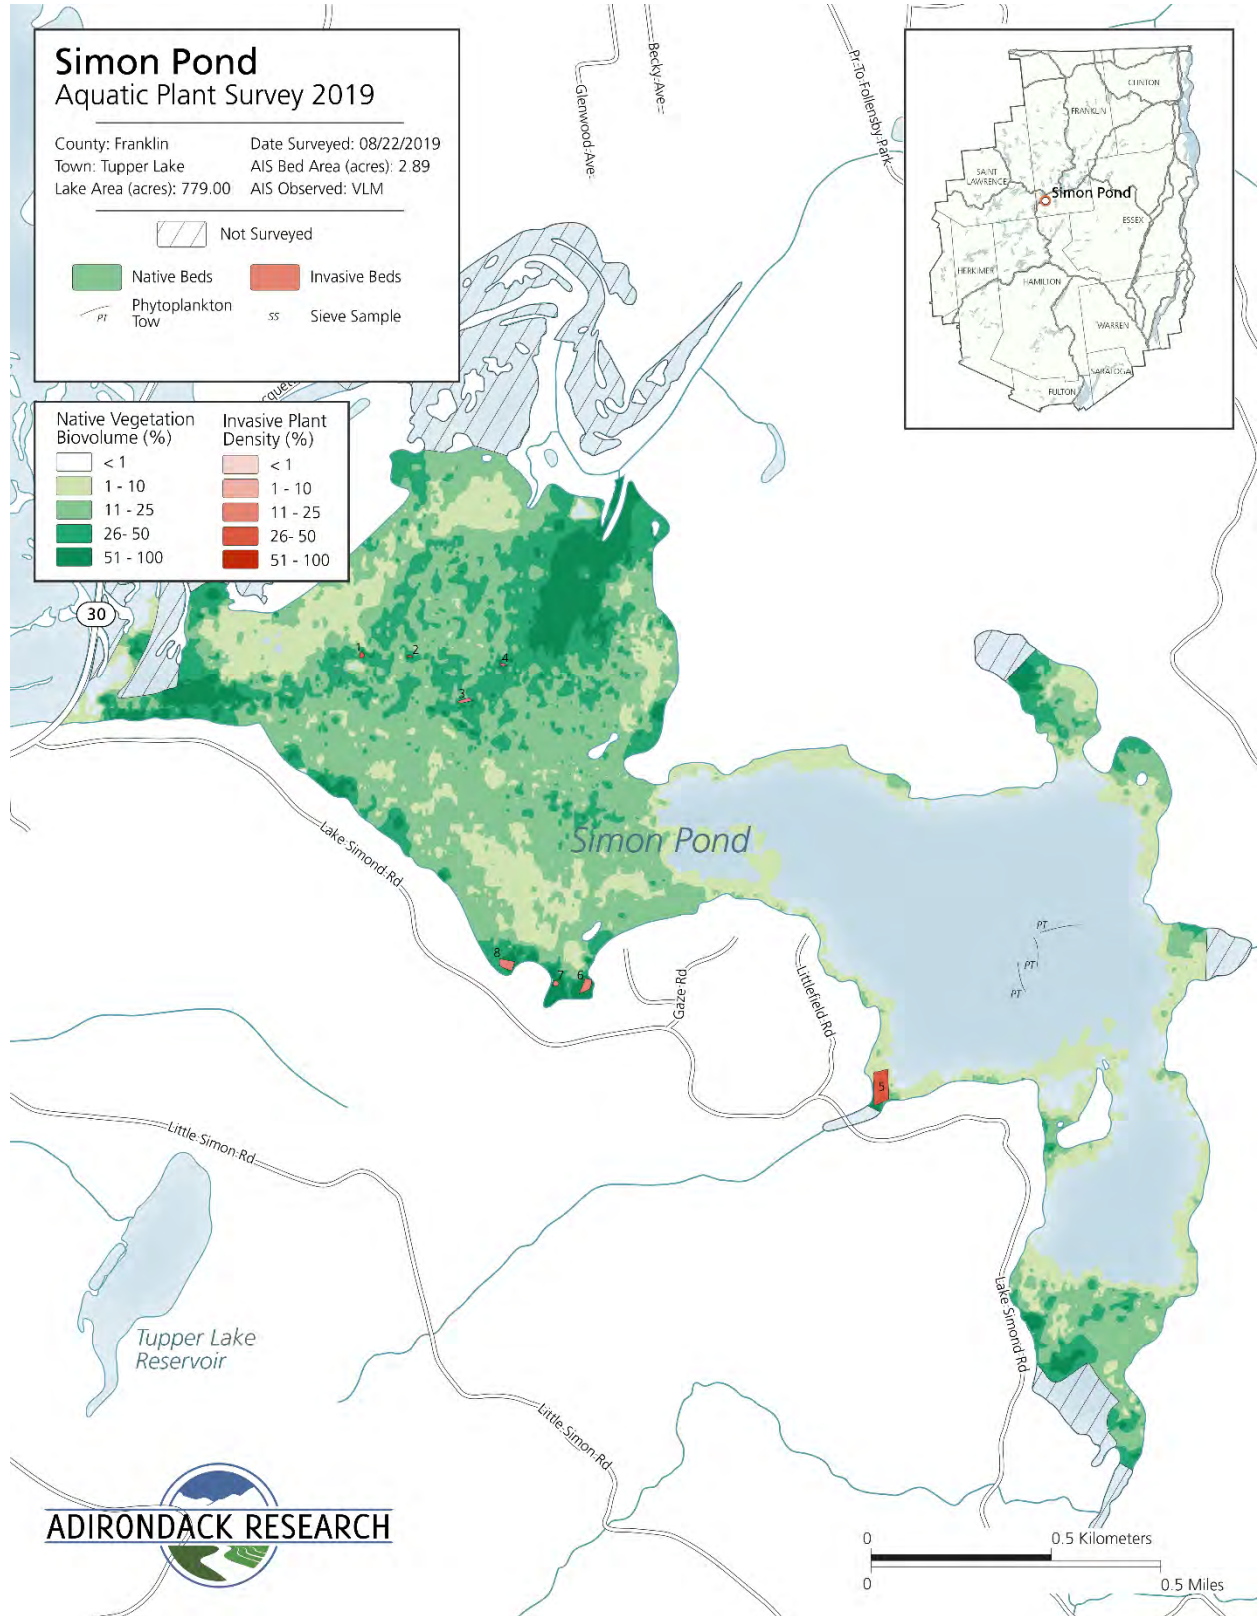
Invasive Species Percent Cover (See map on adjacent page)

Myriophyllum heterophyllum (variable-leaf milfoil) was detected in multiple shallow areas and bays throughout the pond. A total of 8 beds were found.

Bed	Variable Leaf Milfoil			Asian Clam	Spiny Waterflea
	Size (Ac.)	Size (Sq. Ft.)	% Cover	Present (Y/N)	Present (Y/N)
1	.08	3665.50	26-50	No	No
2	.03	1226.14	26-50		
3	.14	6228.94	11-25		
4	.05	2122.50	11-25		
5	1.71	74588.60	26-50		
6	.34	14941.10	11-25		
7	.09	3930.32	11-25		
8	.43	18898.00	11-25
