Utowana Lake, Eckford Chain of Lakes

Survey Date: July 22, 2019

Utowana Lake Aquatic Plant Survey 2019

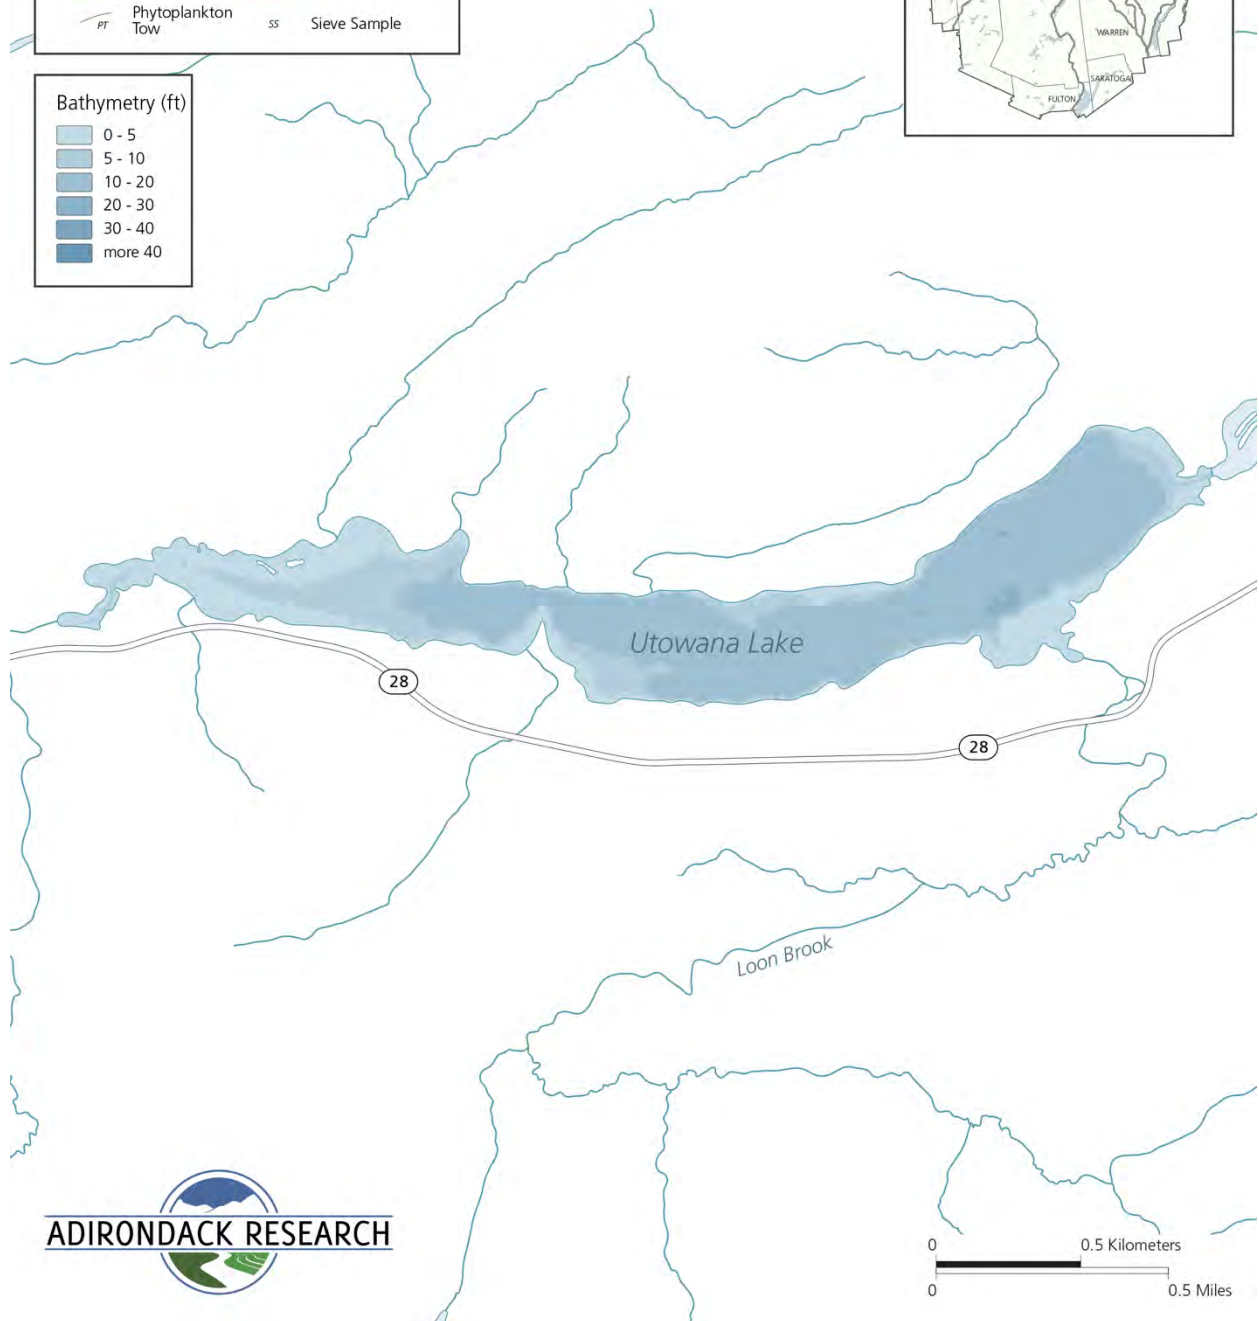
Utowana Lake Aquatic Plant Survey 2019

County: Hamilton Date Surveyed: 07/22/2019
Town: Indian Lake AIS Bed Area (acres): 0
Lake Area (acres): 300.02 AIS Observed:

Bathymetry (ft)
